Water Compliance Inspection Report

Name and Location of Facility Inspected (For industrial users discharging to POTW, also include POTW name and NPDES permit number)	Entry Time/Date	Permit Effective Date
R Bajema Farm Inc 792 E Badger Rd Lynden, WA 98264	9:48 am <u>02/12/2013</u>	
	Exit Time/Date	Permit Expiration Date
	10:00 am <u>02/12/2013</u>	
Name(s) of On-Site Representative(s)/Title(s)/Phone and Fax Number(s)	Other Facility Data (e.g., SIC NAICS, and other descriptive information)	
Roger Bajema, Owner, (b) (6)	Unpermitted	
	Denied Access	
Name, Address of Responsible Official/Title/Phone and Fax Number	NAICS: 11212 <u>8</u>	
Roger Bajema 792 E Badger Rd Lynden, WA 98264	Contacted <input checked="" type="checkbox"/> Yes <input type="checkbox"/> No

Lynden, WA

**Prepared by:
Sandra Brozusky
Environmental Protection Agency, Region 10
Office of Compliance and Enforcement
Inspection and Enforcement Management Unit**

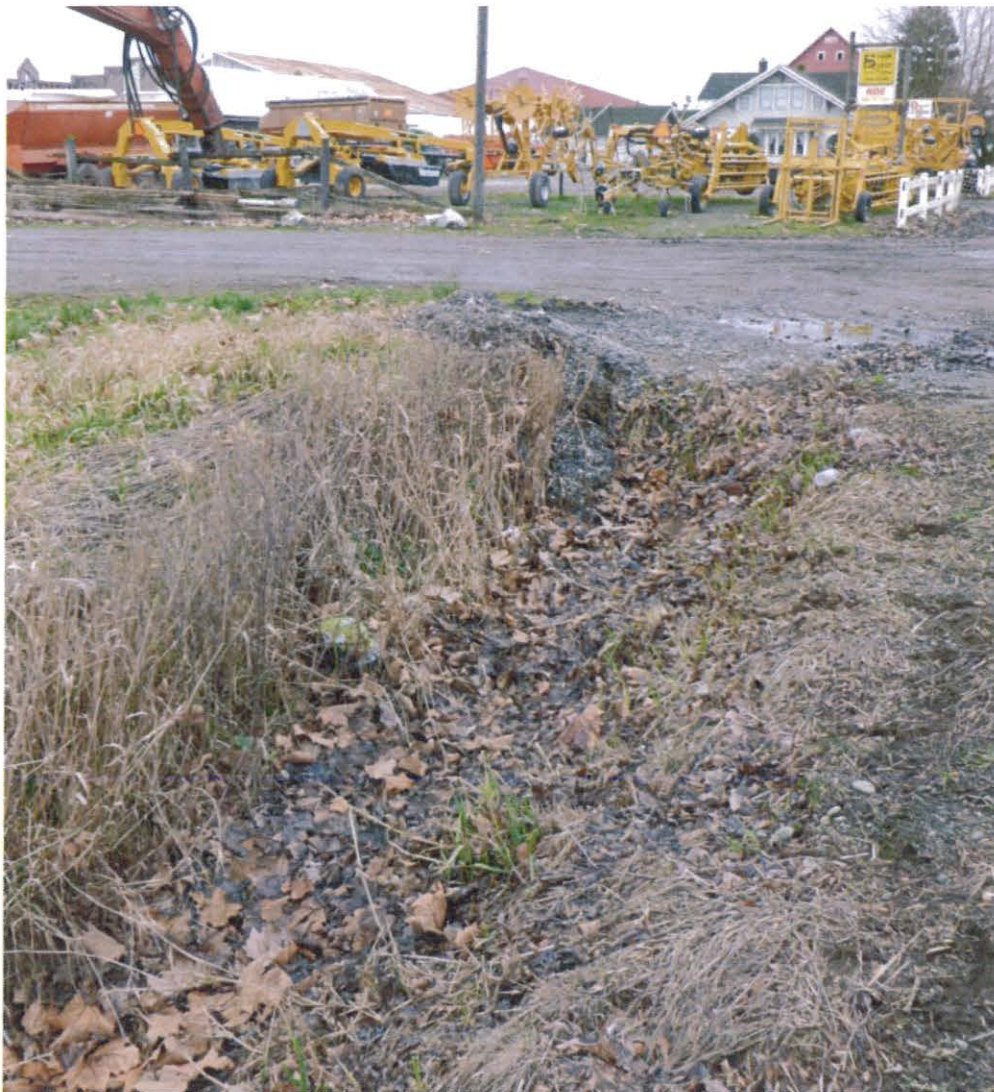
Photograph #20(P1010058-taken on 2/12/13): Looking east, this is a view of a ditch on the west side of the facility, along E. Badger Road. This ditch did not have water flowing on February 12, 2013 and February 21, 2013. There was no observable piping or a culvert that would route water in an easterly direction toward the facility or would suggest that the two ditches were connected. The facility appears in the background.

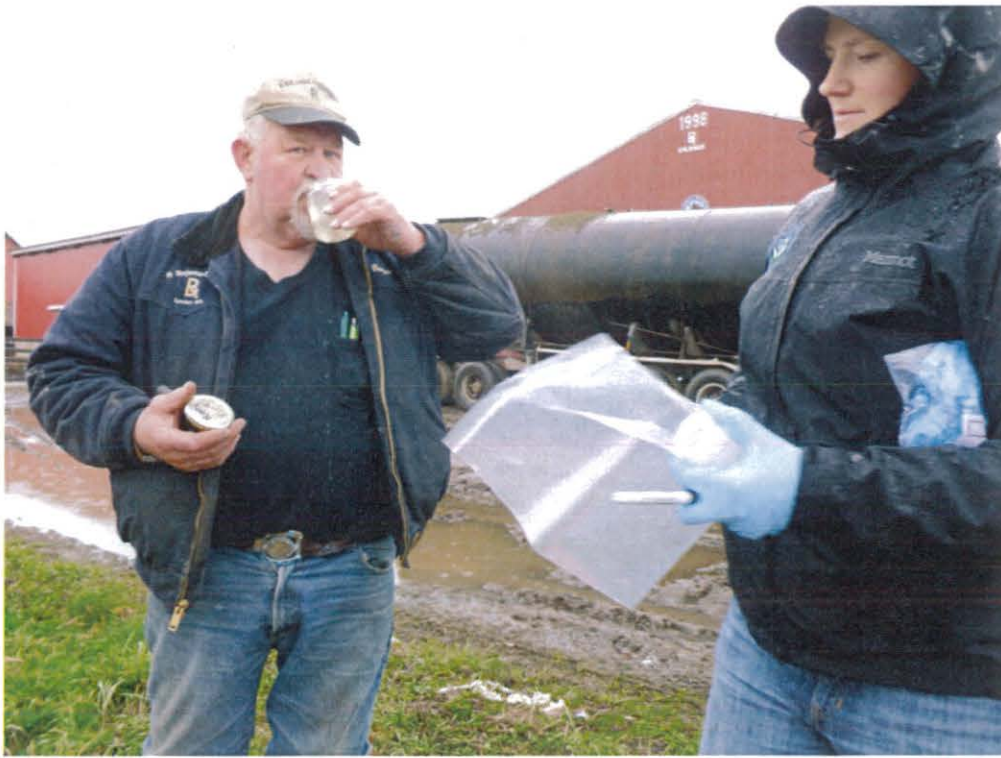
Photograph #21(P1010098-taken on 2/21/13): On February 21, 2013 the EPA inspection team collected water samples. During this time, Mr. Bajema also collected water samples. Mr. Bajema indicated that the water that EPA was collecting was good enough to drink. Mr. Bajema requested that the EPA inspectors take a photograph of him drinking from the sample he collected.

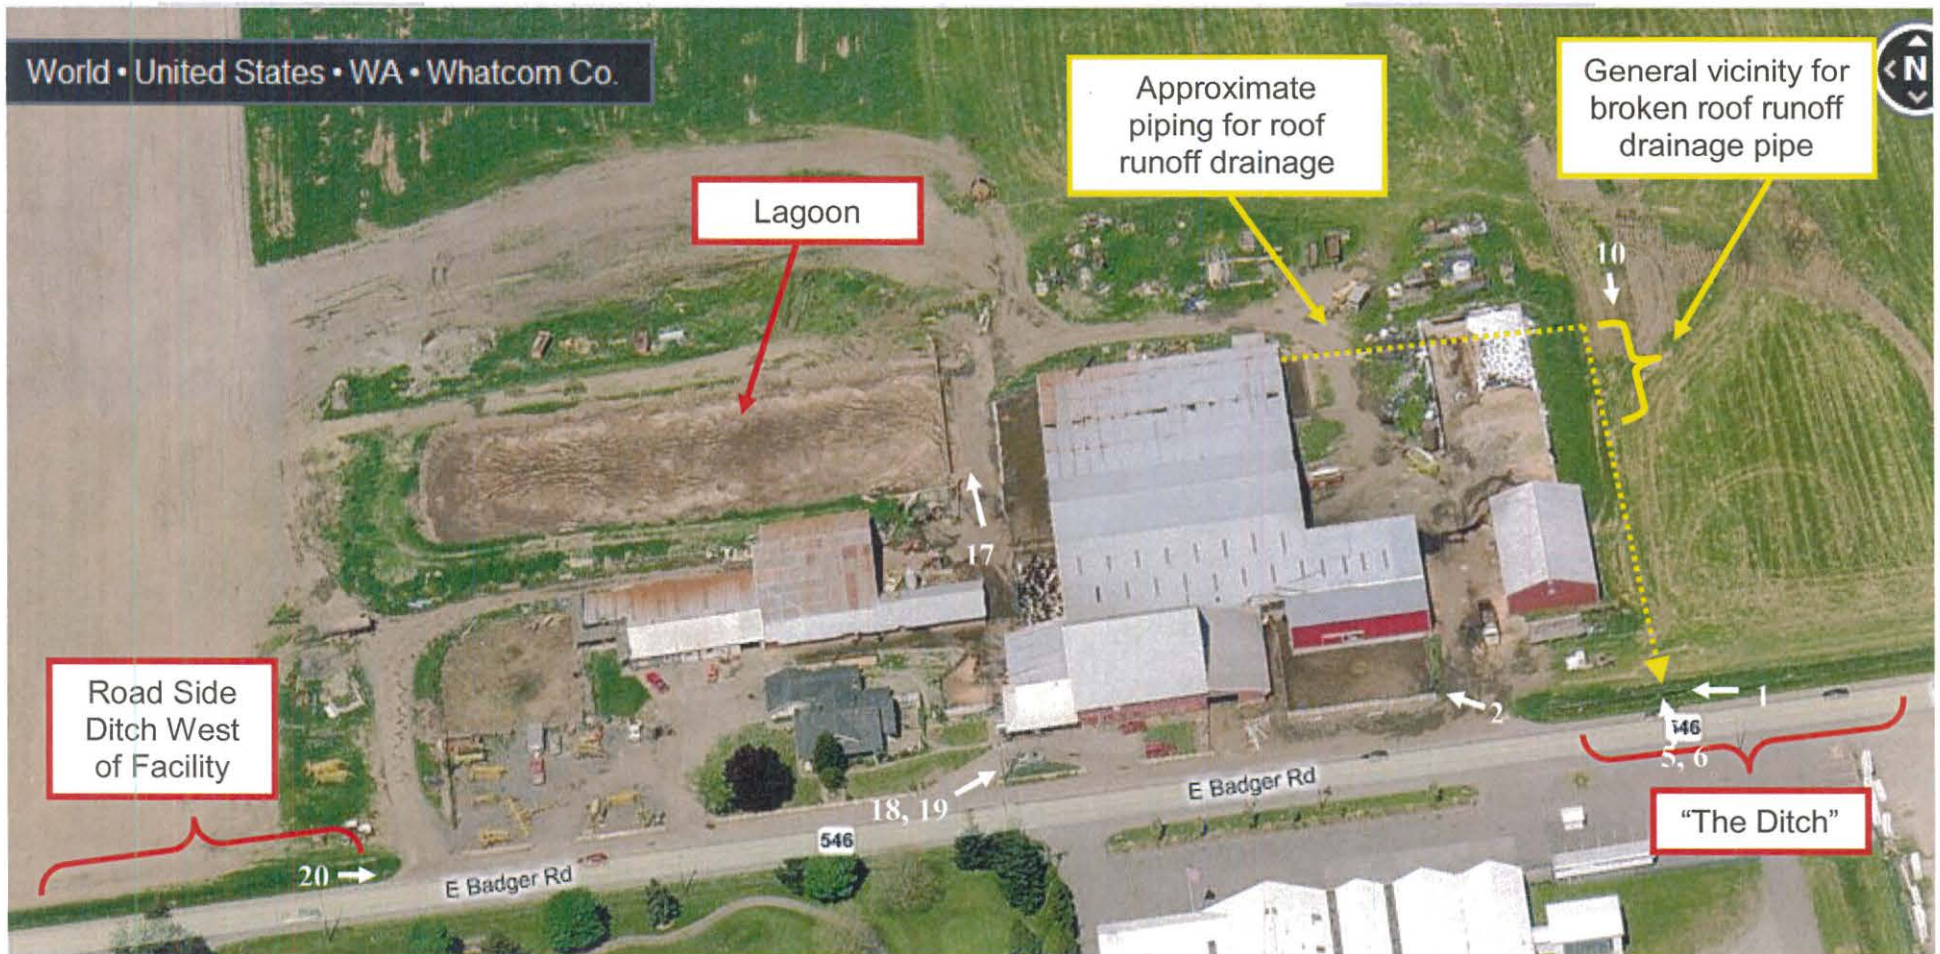
Aerial 1

Contains various photograph locations and direction

Approximately 200 yards west of the beginning surface flow in the ditch is another ditch. On February 12 and 21, 2013 the EPA inspectors walked west of the facility to make observations of any water flowing in this ditch. The EPA inspectors were inquiring about whether the ditch west of the facility may be contributing to the water flow seen in the ditch. On both February 12 and 21, 2013 this ditch west of the facility did not have water flowing in it. This ditch did not have observable piping or a culvert that would suggest the two ditches were connected. In addition, Mr. Isensee stated that this additional ditch on the west side of the facility is slopped in a westerly direction, away from the facility. See attachment A photograph 20 for a view of this ditch and attachment B aerial 1 for the location of this ditch.
